TC-800 Camera

Feature

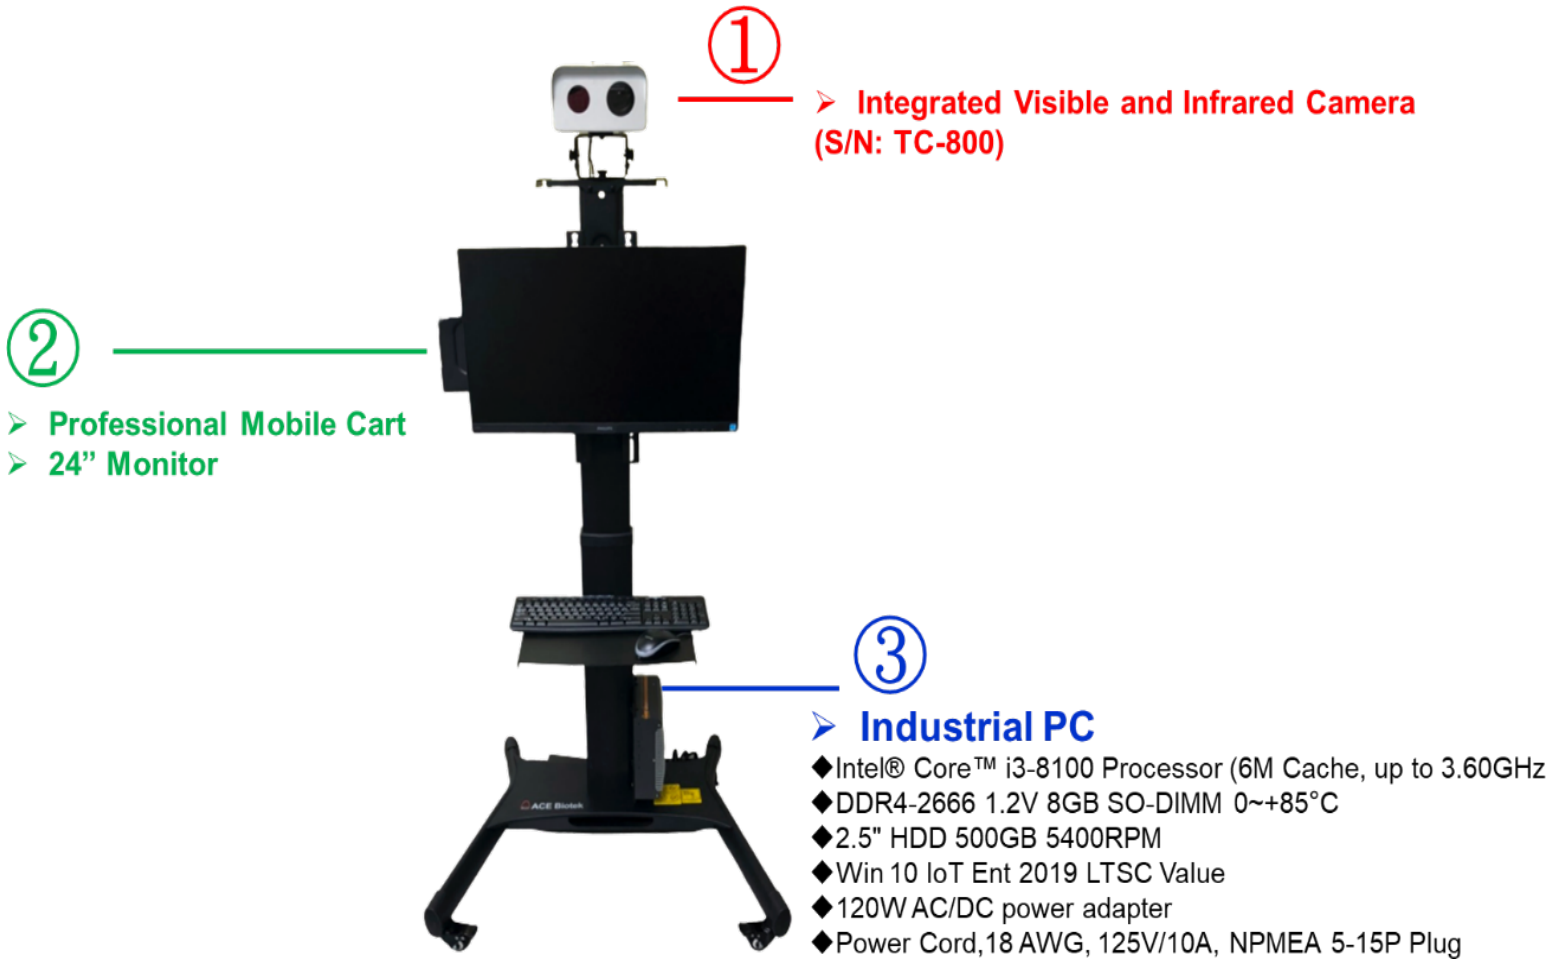
TC-800 Portable Cart

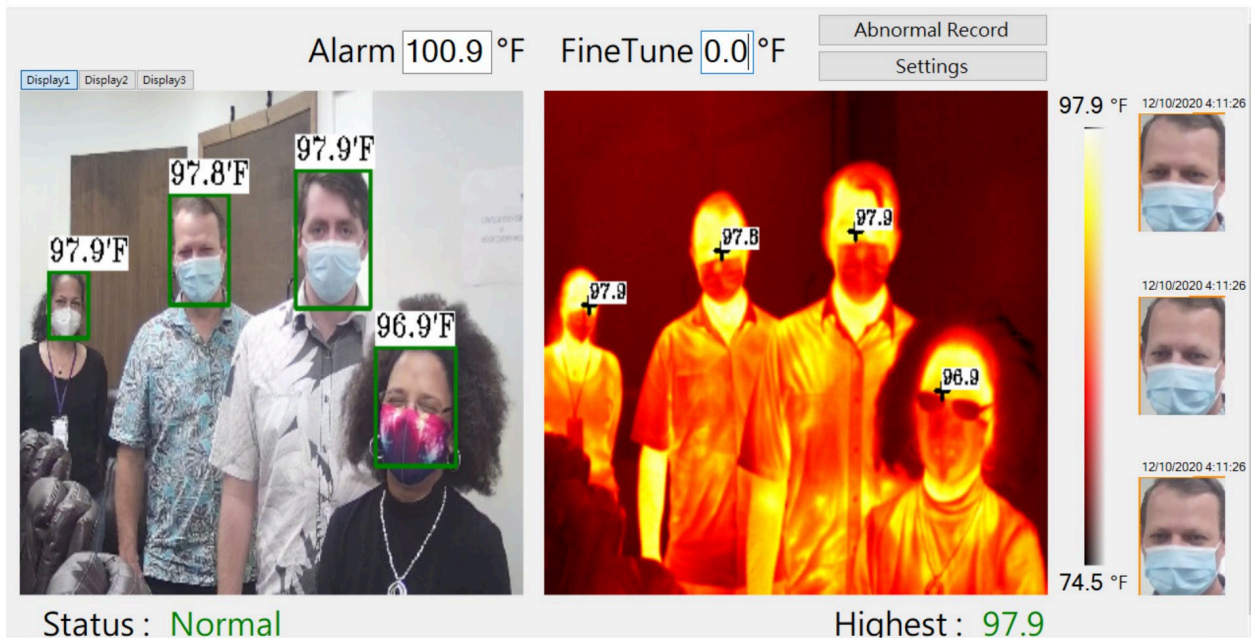
TC-800 Multiple Faces Temperature Detection (Dynamic detection)

97.9°F 97.8°F 97.9°F 96.9°F

Status: **Normal** Highest: **97.9**

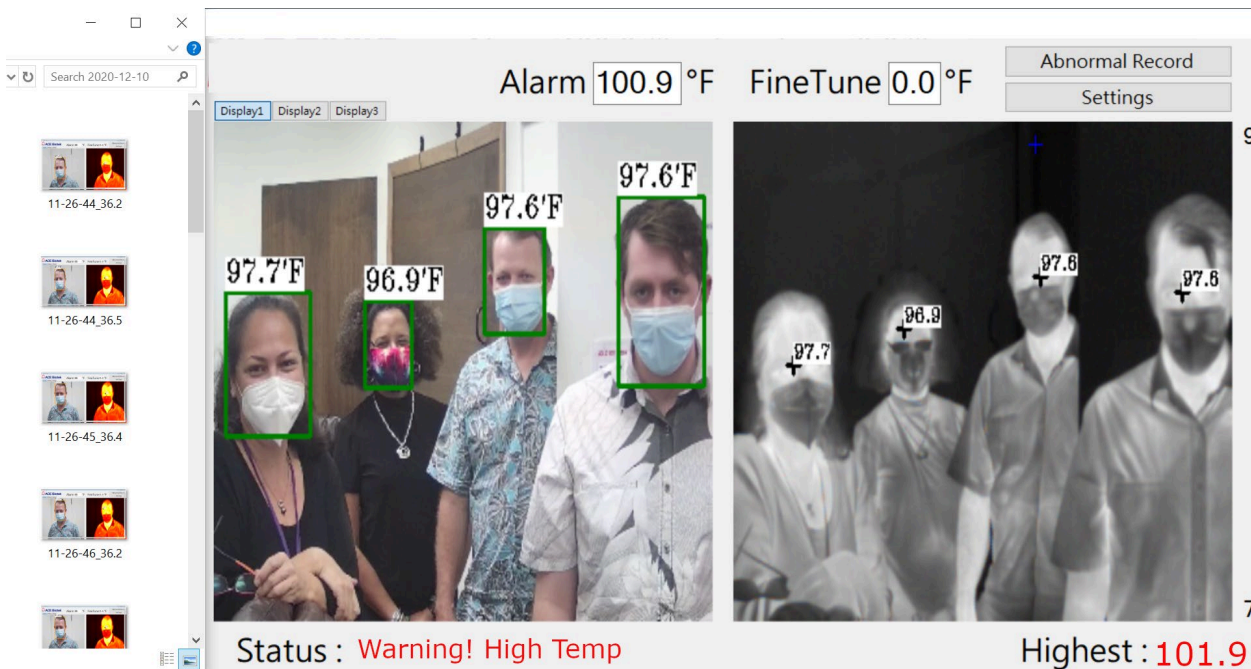
TC-800 Automatic Abnormal State Alarm and Image Capture

Status: **Warning! High Temp** Highest: **101.9**
